1  
ESL-TR-85-23

## Optimum Aircraft Rescue Tool

FINAL REPORT

ENGINEERING & SERVICES LABORATORY  
AIR FORCE ENGINEERING & SERVICES CENTER  
TYNDALL AIR FORCE BASE, FLORIDA 32403

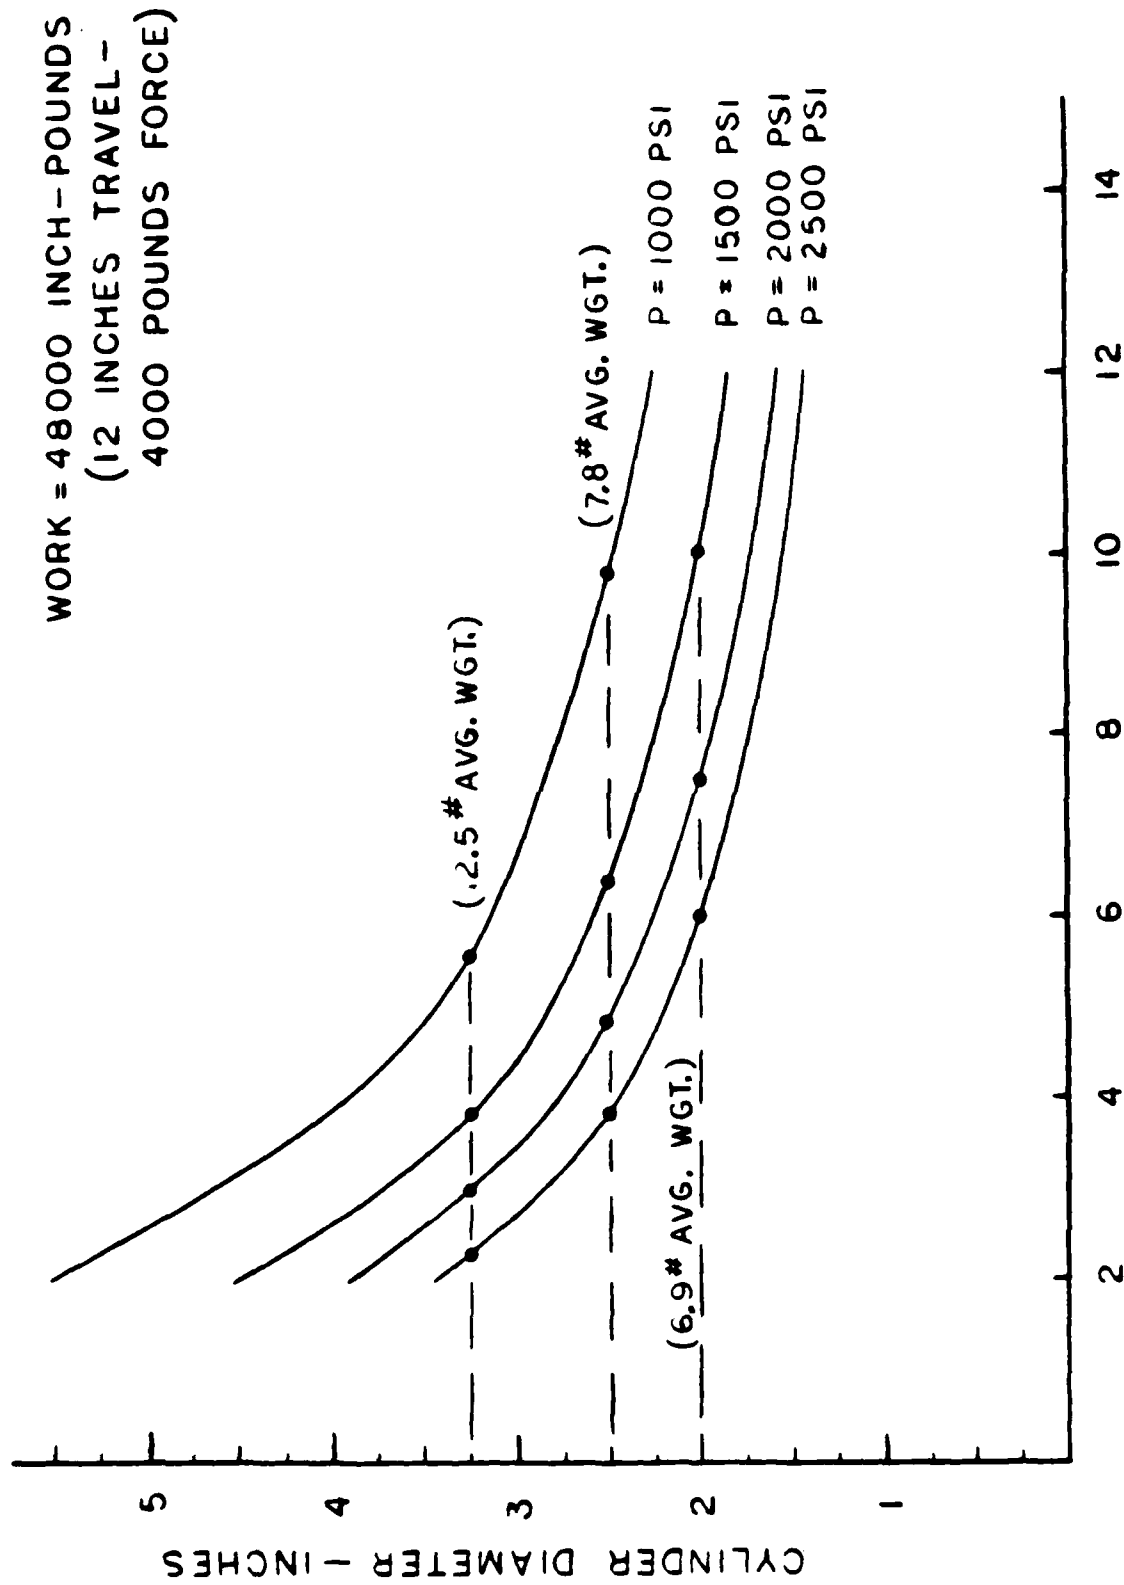
Figure 1. Cylinder Weight Analysis

Figure 1 is a plot of cylinder diameter versus stroke for constant work of 48,000 inch-pounds at working pressures of 1,000, 1,500, 2,000, and 2,500 psi.

Three standard cylinder diameters were found to bound the potential size: namely, 3.25-inch, 2.5-inch, and 2-inch diameter. Weights were calculated for these sizes and the corresponding stroke at each pressure level given in Figure 1.

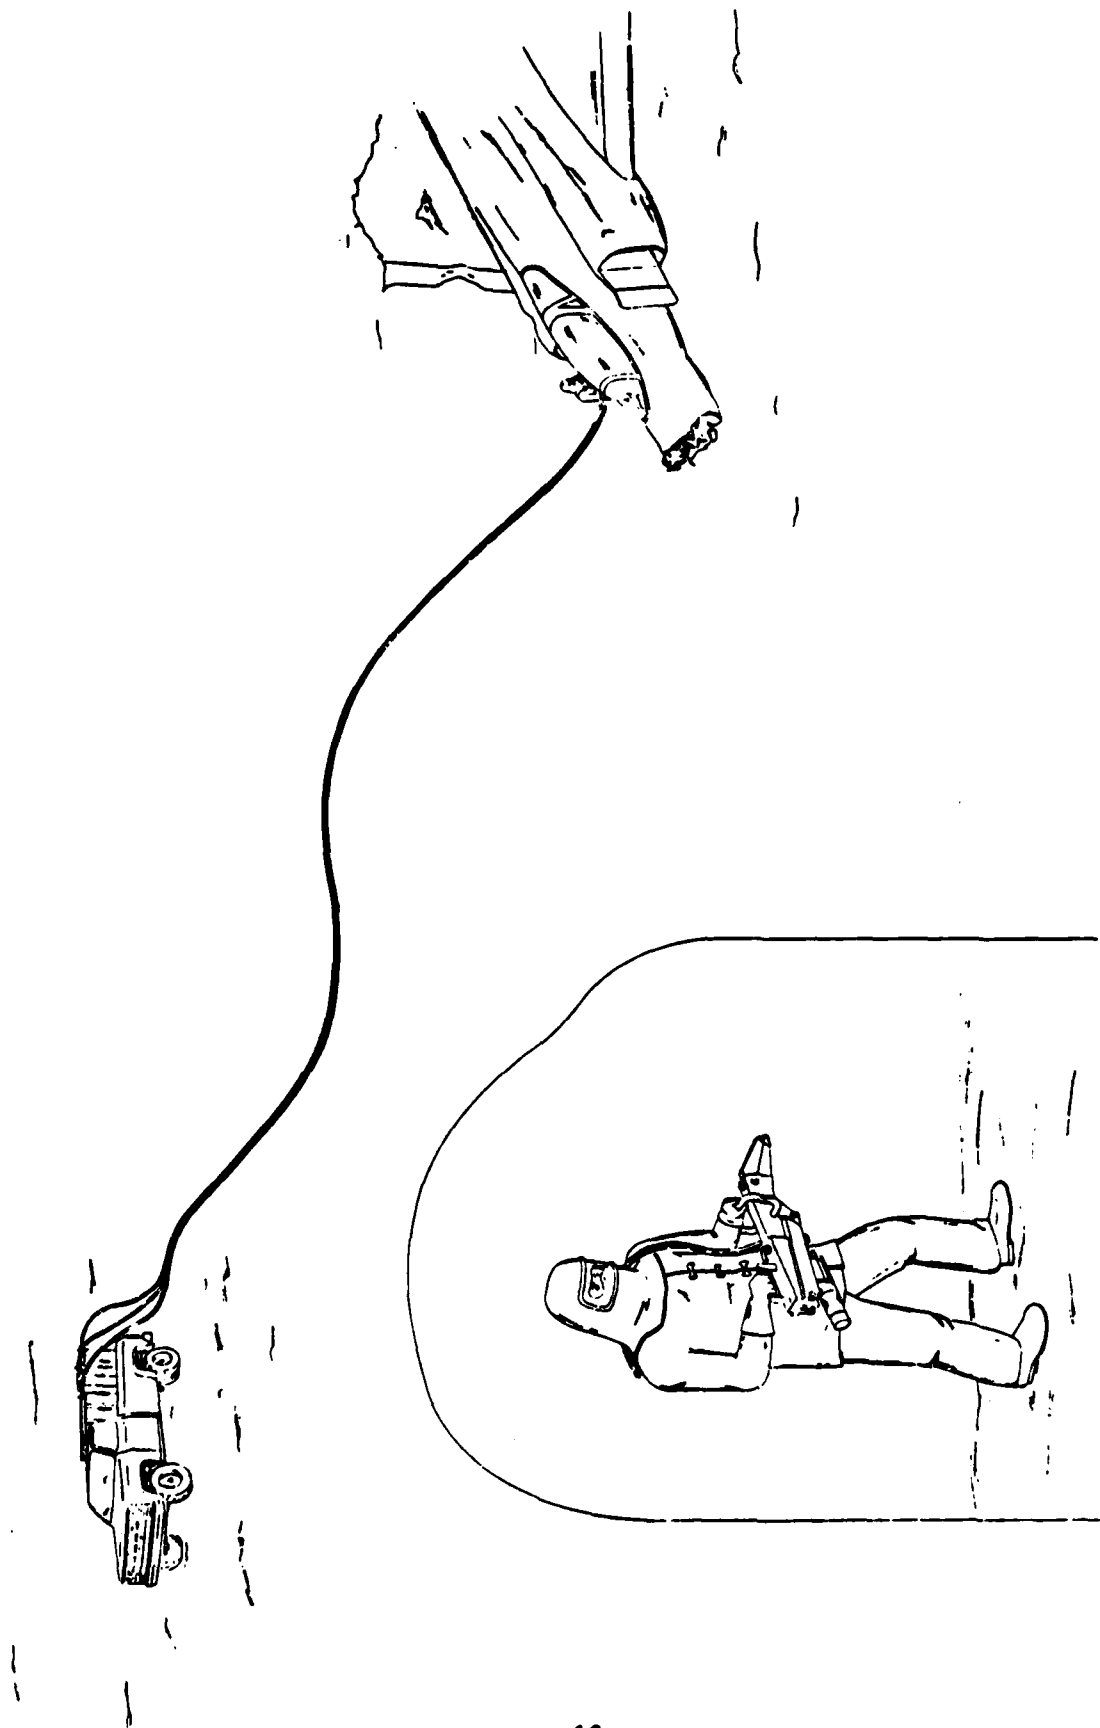
Figure 2. Typical Rescue Scene for Optimum Aircraft Rescue Tool

Compressed air has been selected as the power source for the rescue tool. The normal scenario for a rescue operation will have the PIO Rescue Truck with a crew of three gain a position within 200 feet of the aircraft after the fire trucks have extinguished the fire in the downed aircraft, illustrated in Figure 2. The compressed air will be stored and transported in the rescue vehicle. From the rescue vehicle, it will be furnished to the tool through hoses.

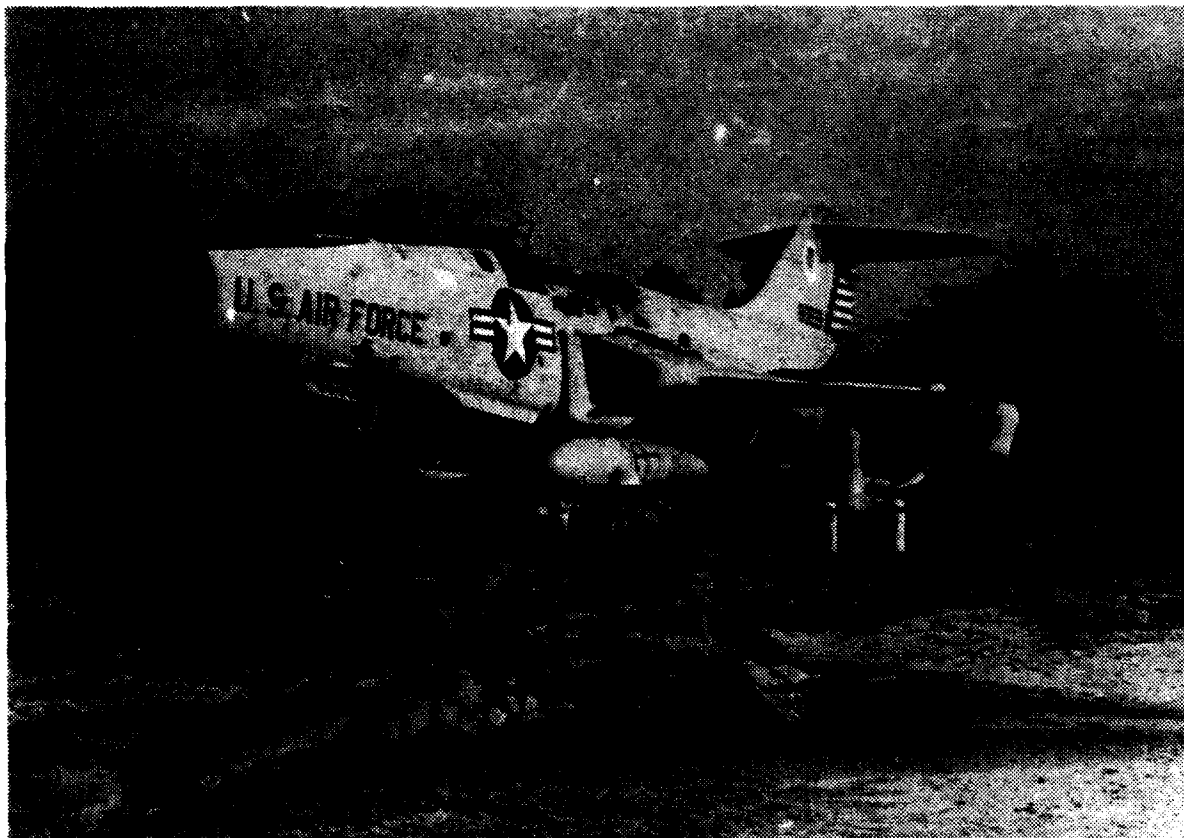
Figure 3. Test Site and Aircraft

An F-101 that had been previously damaged by practice strafing was selected by the Air Force as the test aircraft. After a day of equipment delivery and assembly, testing began Tuesday, 15 November 1983. Figure 3 depicts the test site and aircraft.

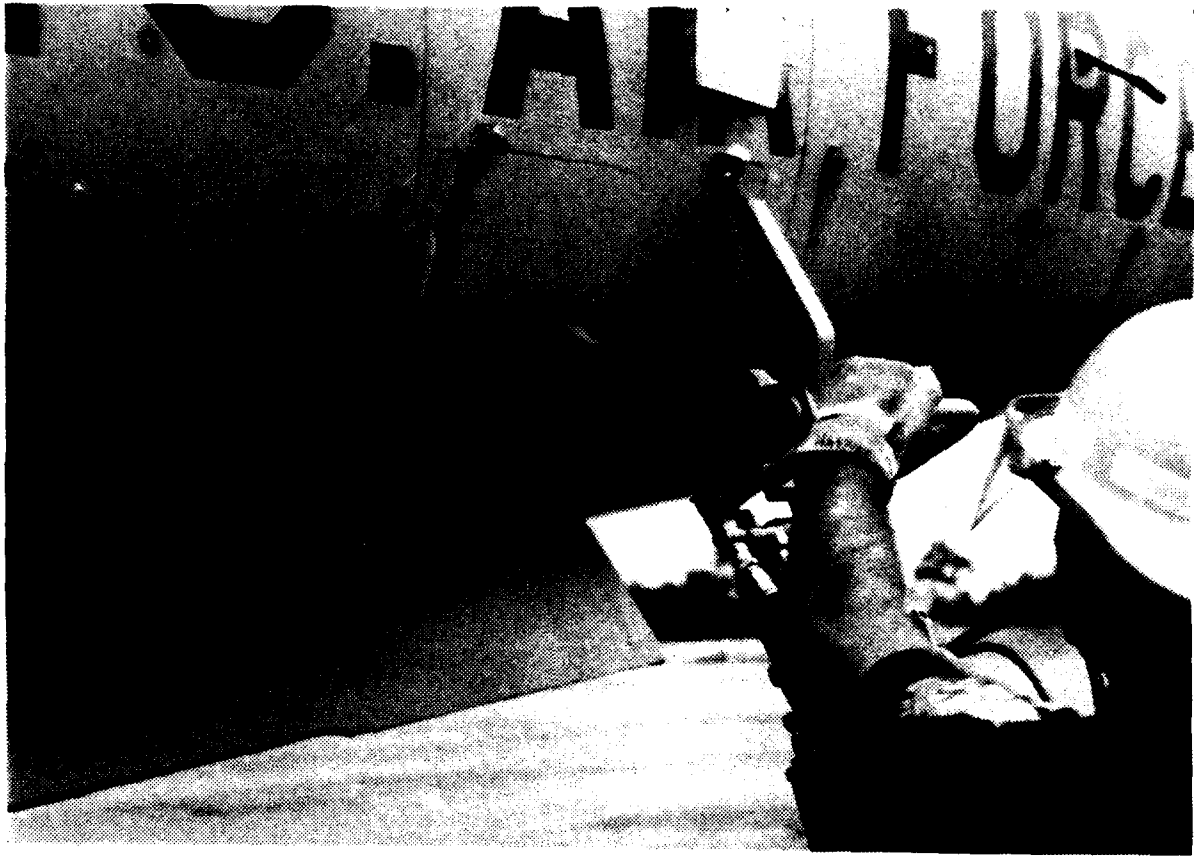
Figure 5. Access Hole Through Aircraft  
(Lower Forebody Test)

These tests demonstrated the basic tool capability in cutting an 18-inch by 24-inch access hole into the aircraft body. Three individual tests were conducted. The first test was conducted with the user standing on the ground and penetrating the lower forebody of the aircraft. The tool performed the test without difficulty. The second test was conducted with the fireman upon a ladder penetrating the area below the cockpit. Some difficulty in handling the tool was noted due to the ladder restrictions and the location of the tool handles. Mechanically, the rescue tool operated adequately with test approval from the Air Force project engineer. A third test was attempted on the upper rear fuselage with the user standing on the wing. Several penetration points were made, but a rainstorm forced the test to an end without completion. The only problem encountered involved the time required to cut the 18-inch by 24-inch openings (approximately 12 minutes for the first test and 24 minutes for the second test). It should be noted that considerable time was spent discussing tool operation without actual cutting during the test. This added extra time to the effort. Figure 5 shows the lower forebody test of this series, and Figure 6 shows the ladder test.

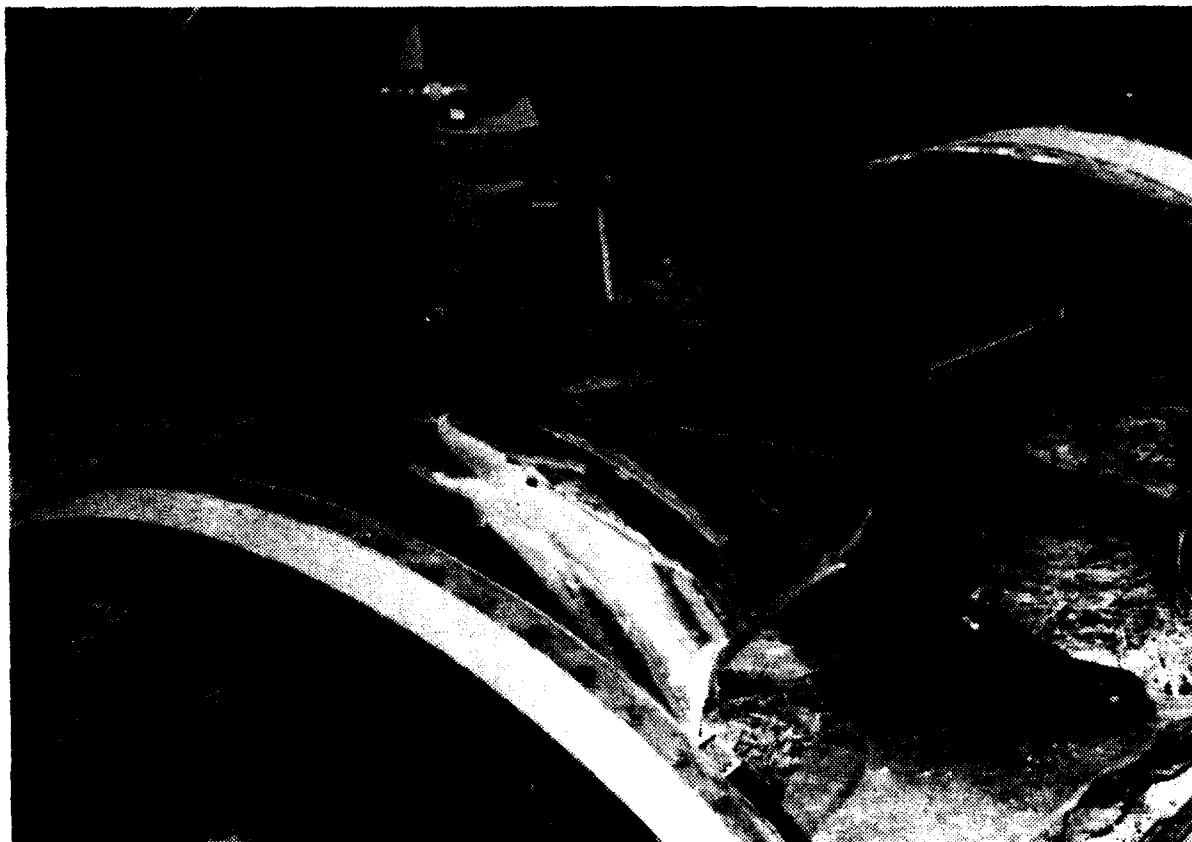
Figure 7. Canopy Penetration and Cutting with Router

Four tests were undertaken to determine the router's capability in penetrating and cutting canopy acrylic material. The canopy was not attached to the aircraft but was placed on the ground. A 1/4-inch diameter burr bit with a 118-degree drill point was used as the test cutter during Tests 7, 8, and 9. The tests indicated that the router was capable of penetrating and cutting the canopy material (3/8-inch acrylic) adequately (Figure 7). The attempt to cut windscreen material on the F-101 did not prove successful due to the material difference between the windscreen and canopy.

Problems were encountered with the adaptor collet used to interface between the internal router collet and cutting bit. During several instances, the adaptor collet worked out of the router collet. The setscrew holding the cutting bit inside the adaptor collet also became loose, thus, allowing the bit to turn inside the collet. These problems were encountered during extended cutting periods under excessive vibration. The collet and setscrew problem has since been corrected. These corrections are discussed later in this section.

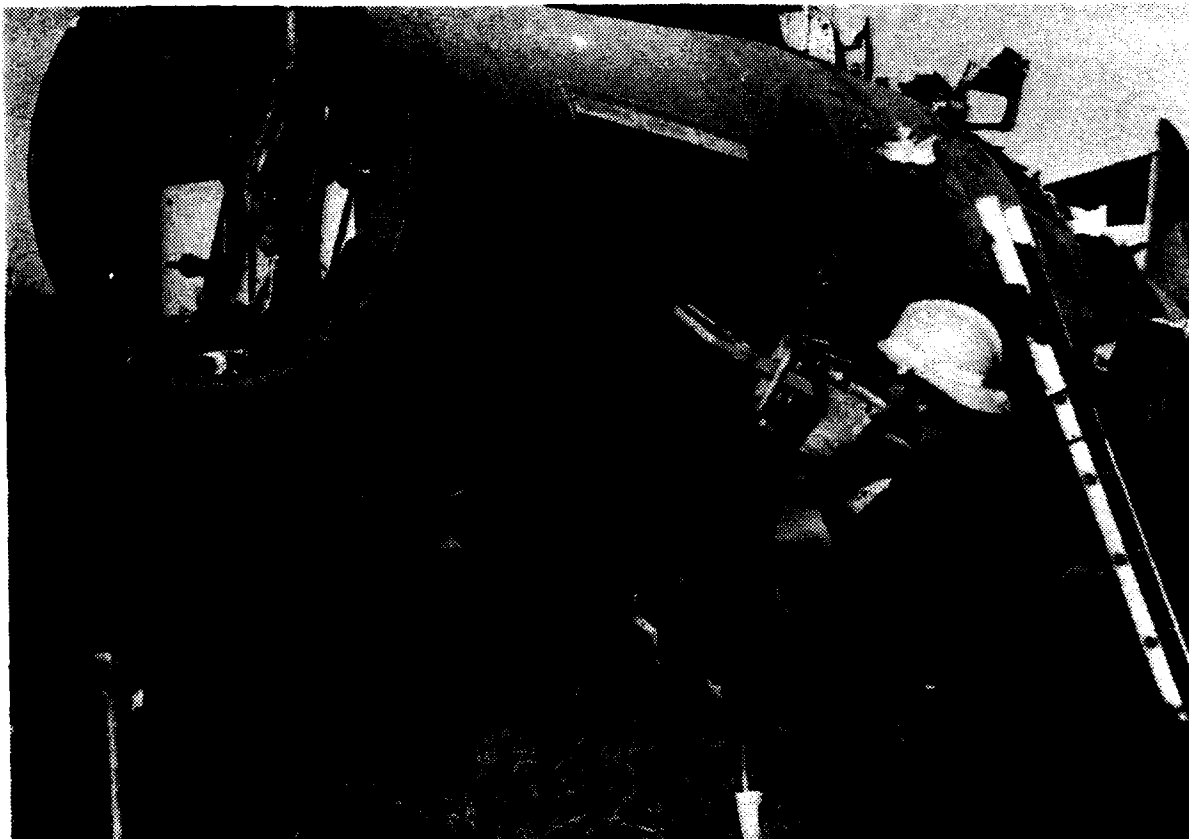
Figure 8. Forcing of Access Panel Test

The access panel tests were undertaken to determine the capability of the rescue tool to force a panel open on the aircraft. In Test 11, a panel located on the lower forebody and secured by means of quarter-turn fasteners was selected for the test. The router was used to penetrate the aircraft skin. As before, difficulty was encountered with the adaptor collet and setscrew; however, a hole in the skin was made by router action of adequate size to start the spreader jaws operation. The quarter-turn fasteners were easily broken by spreader action. The surrounding aircraft skin and structural material were crushed, and this prevented the panel from truly being forced open.

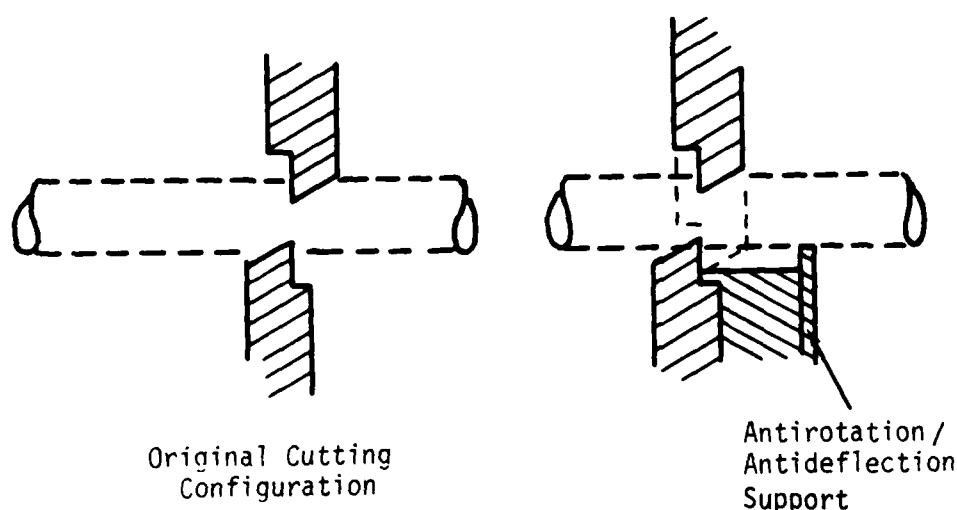
Figure 9. Optimum Working Model

The previously ground outside relief angle and resulting flat across the lower blade edge was modified such that the flat was reduced from .032 inch to approximately .015 inch, leaving essentially a knife edge near the tip. This improved the cutting capability of the tool; however, further investigation indicated that as the blades engaged the hose near the tips, a tendency for the hose to rotate about the axis of the blades developed, making an actual penetration of the ballistic hose material more difficult. A method of reacting against this hose rotation was conceived as an insert located inside the blade shoulder and extending outward. Several iterations of inserts were tried until an optimum working model was achieved. Figure 9 depicts this configuration.

The antirotational support impedes the hose rotation as the cutting blades pierce the material. Since the tendency for rotation is reacted as the blades progress through the hose, a side force is exerted on the blades which cancels the tendency for transverse blade deflection (separation).

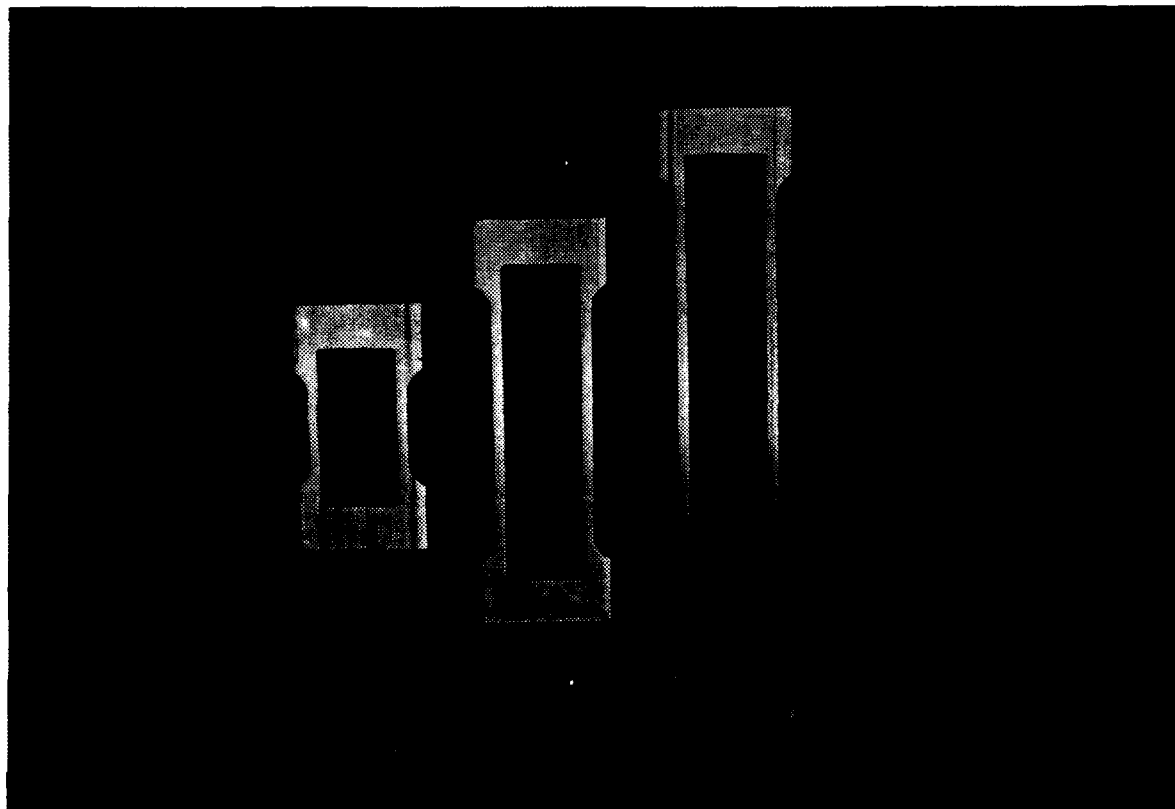
Figure 10. Three Test Specimen Sizes  
(3-, 6-, and 10-inch)

Several test specimens were broken by the use of a tensile testing machine to accurately determine the ultimate tensile strength of the selected material. The test material selected was 6061-T6 aluminum due to its tensile strength and material availability. The test results indicated an average ultimate tensile strength of 45,479 pounds per square inch with a standard deviation of 356 pounds per square inch for the specimen bar stock. The actual rescue tool test articles were adjusted in cross-sectional area to break at 8,000 pounds maximum (nominally 7,500 pounds) force. Three sizes of test specimens were fabricated for an outside jaw opening dimension of 3 inches, 6 inches, and 10 inches. Figure 10 shows the three test specimen sizes.

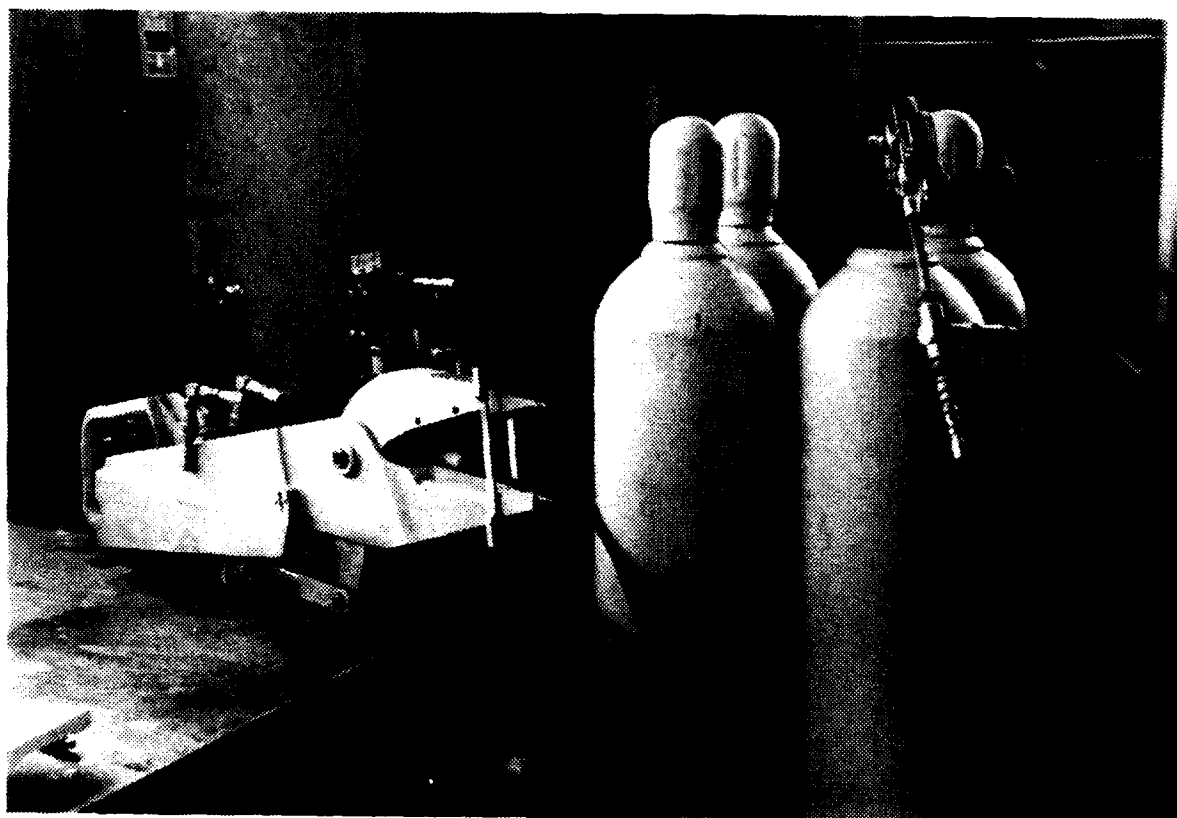
Figure 11. Initial Test Setup

Each size specimen was tested with the rescue tool. To accommodate the test specimen geometry, each specimen was set in the first barb of the upper and lower stainless steel jaw-edge plate. Figure 11 shows the test setup. The jaw spreading force was then adjusted by opening the hydraulic direction control valve and slowly increasing the air pressure to the hydraulic pump by means of the air supply regulator. Each specimen broke at approximately 110 psig, thus, indicating correct operation of the hydraulic system and the spreading jaw mechanism. Figure 12 shows the broken specimen after testing.

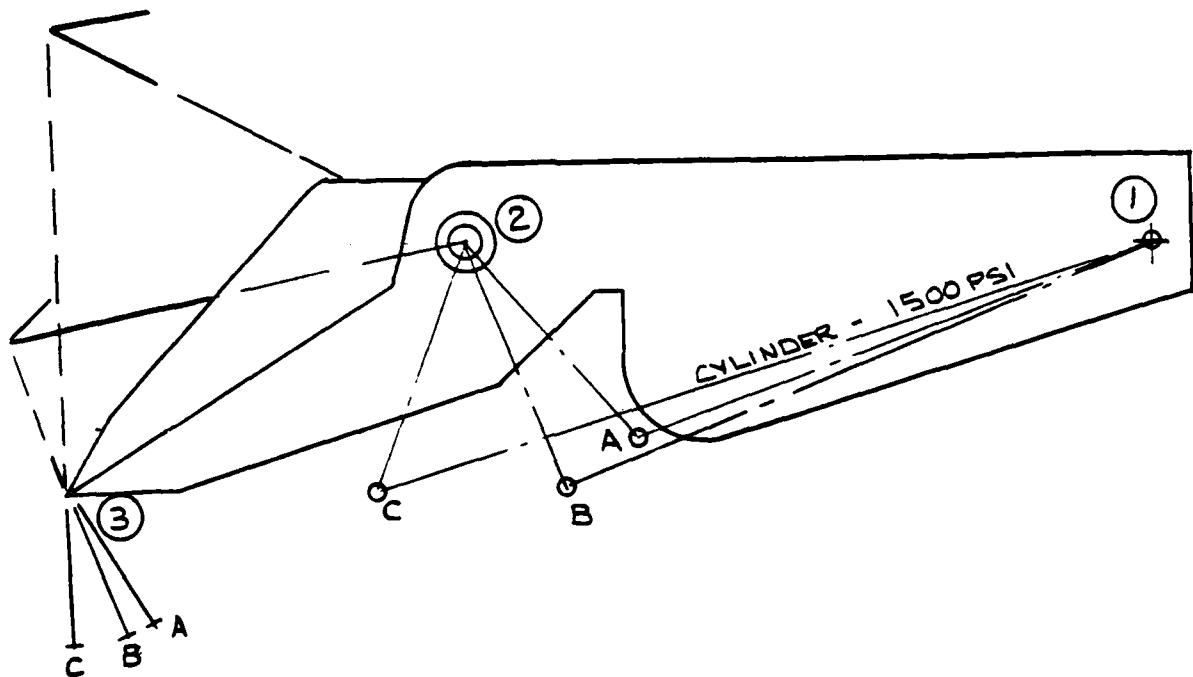
CUTTER-SPREADER LOADS

Loads based on 2 1/2-inch diameter cylinder at 1,500 psig.

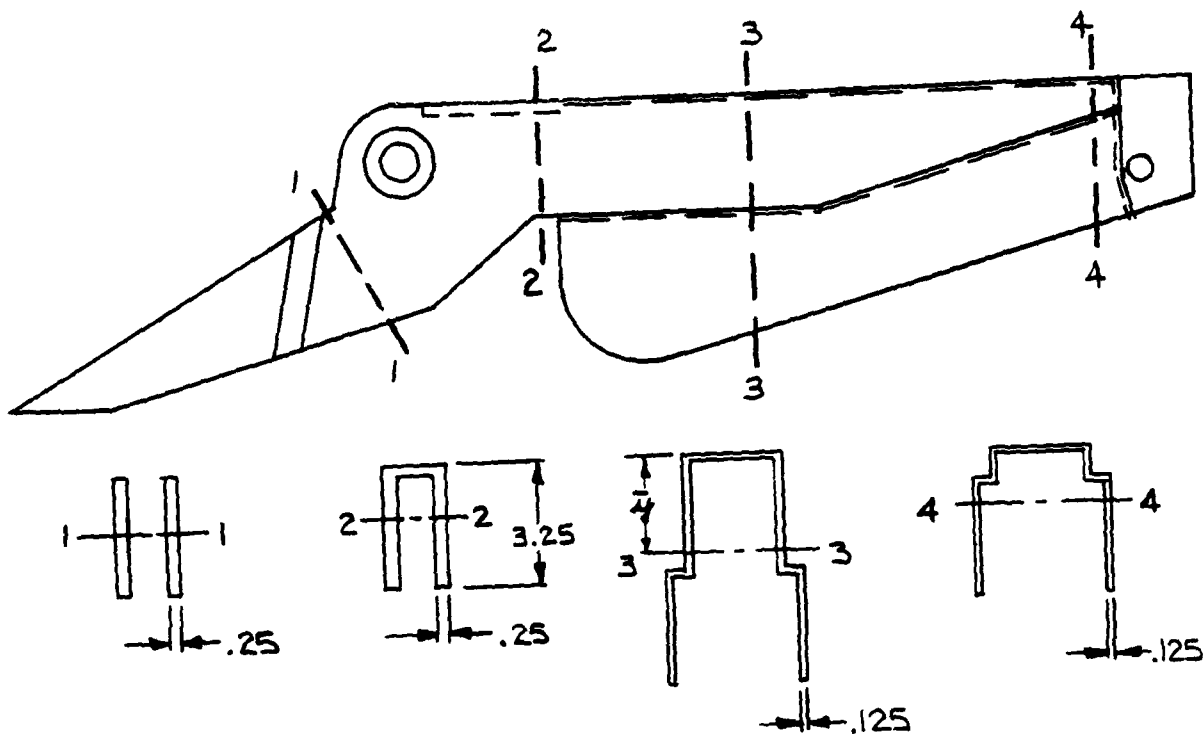
Body Assembly

$A_1 = 1.5 \text{ in}^2$	$A_2 = 1.8125$	$A_3 = 1.93 \text{ in}^2$	$A_4 = 1.4 \text{ in}^2$
$\bar{y}_1 = 1.5 \text{ in}$	$\bar{y}_2 = 1.367 \text{ in}$	$\bar{y}_3 = 2.627 \text{ in}$	$\bar{y}_4 = 1.521 \text{ in}$
$I_{1-1} = 1.125 \text{ in}^4$	$I_{2-2} = 1.72 \text{ in}^4$	$I_{3-3} = 6.95 \text{ in}^4$	$I_{4-4} = 2.2 \text{ in}^4$

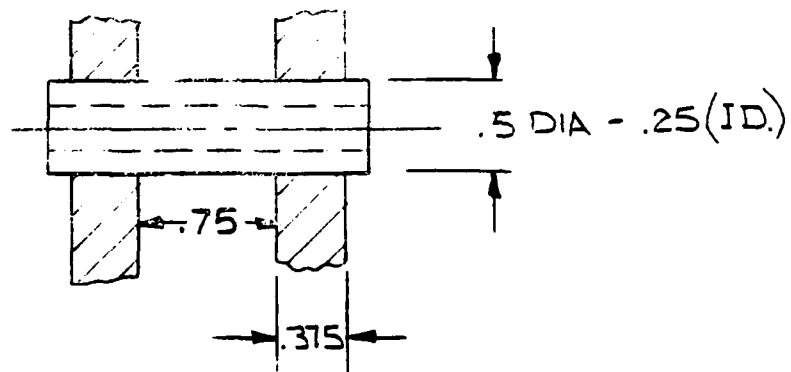
Pin in Double Shear

$$f_s = \frac{P}{A} = \frac{7363 \times 4}{2 \times (.5^2 - .25^2) \pi} = 25,000 \text{ lbs/in}^2$$

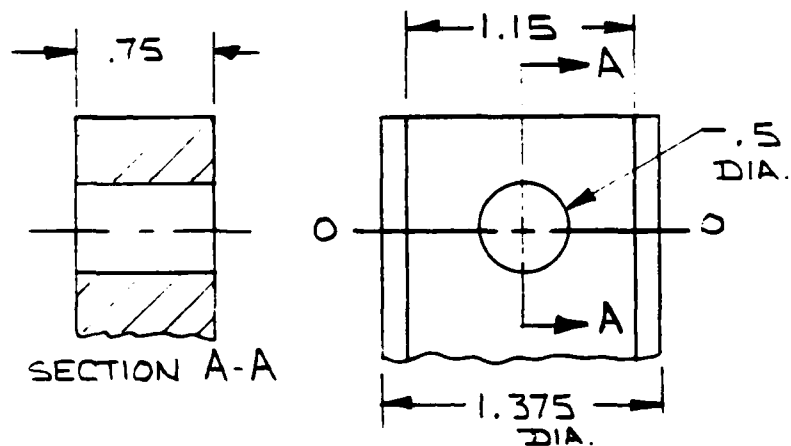
Tensile Load; 0-0

$$f_t = \frac{P}{A} = \frac{7363}{.75 (1.15 - .5)} = 15,100 \text{ lbs/in}^2$$

$$\text{M.S.} = \frac{65,000 (.75)}{15,100} - 1 = +2.22 \text{ (high)}$$

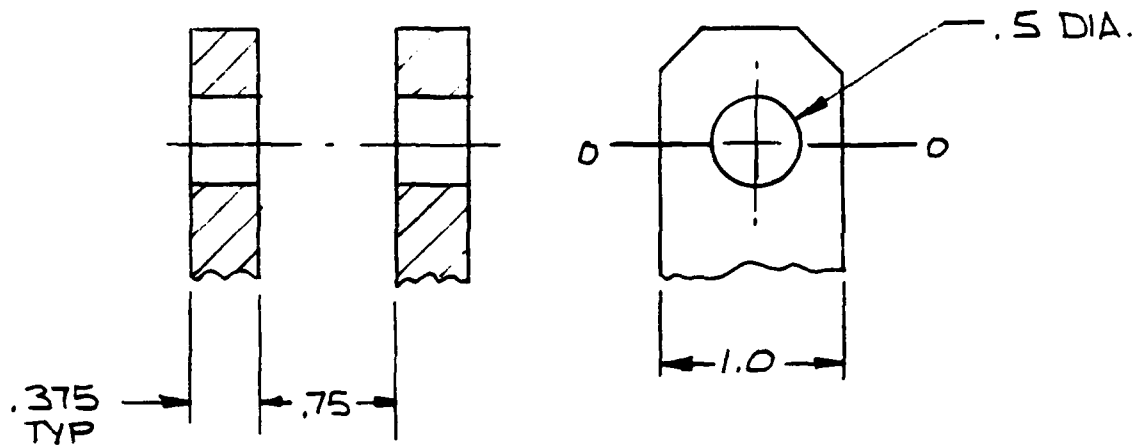
Actuator Rod End

Tensile Load; 0-0

$$\text{M.S.} = \frac{65,000 (.75)}{19,634} - 1 = +1.48$$

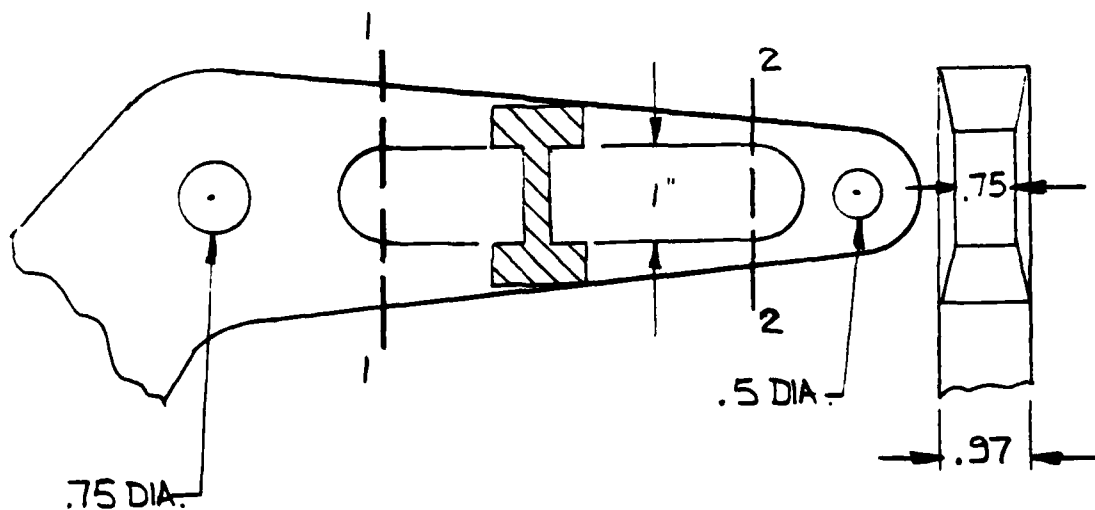
Lever Arm

1/2-inch Diameter Pivot Pin (.625R Arm) -- Maximum Load 7363 pounds

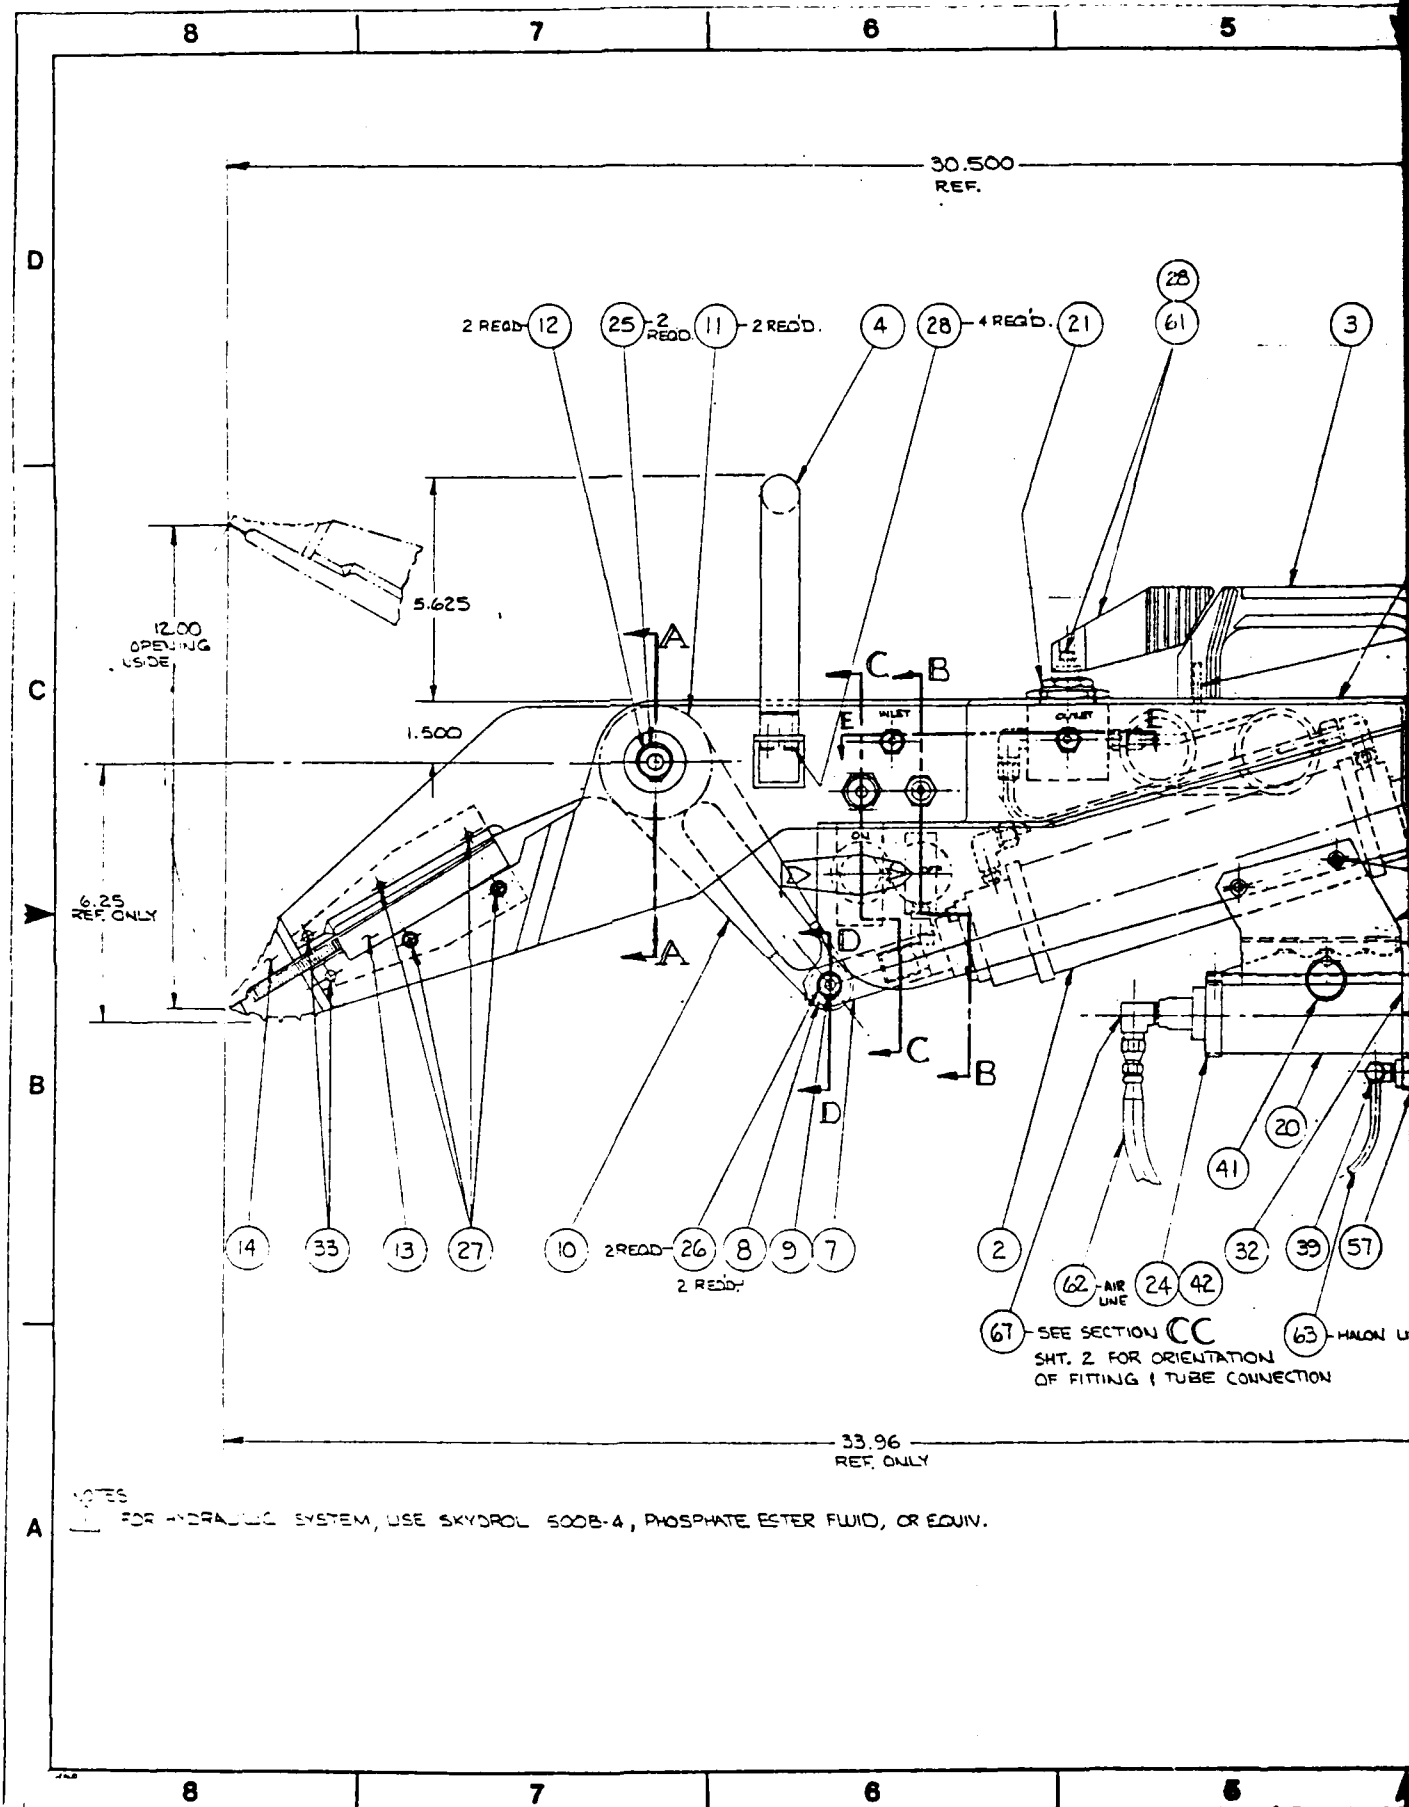
Figure B-1.

The rescue tool assembly is depicted by Figure B-1 (SRL Drawing 3973-16-5967). The system schematic diagram is contained on Figure B-2 (SRL Drawing No. 3973-16-5977). The rescue tool (reference Figures B-1 and B-2)

consists of the spreader/cutter mechanism and cylinder, router, associated spark guard and Halon nozzle control valves, and the body structural members. This assembly, due to its mobility requirements, weighs approximately 25 pounds.

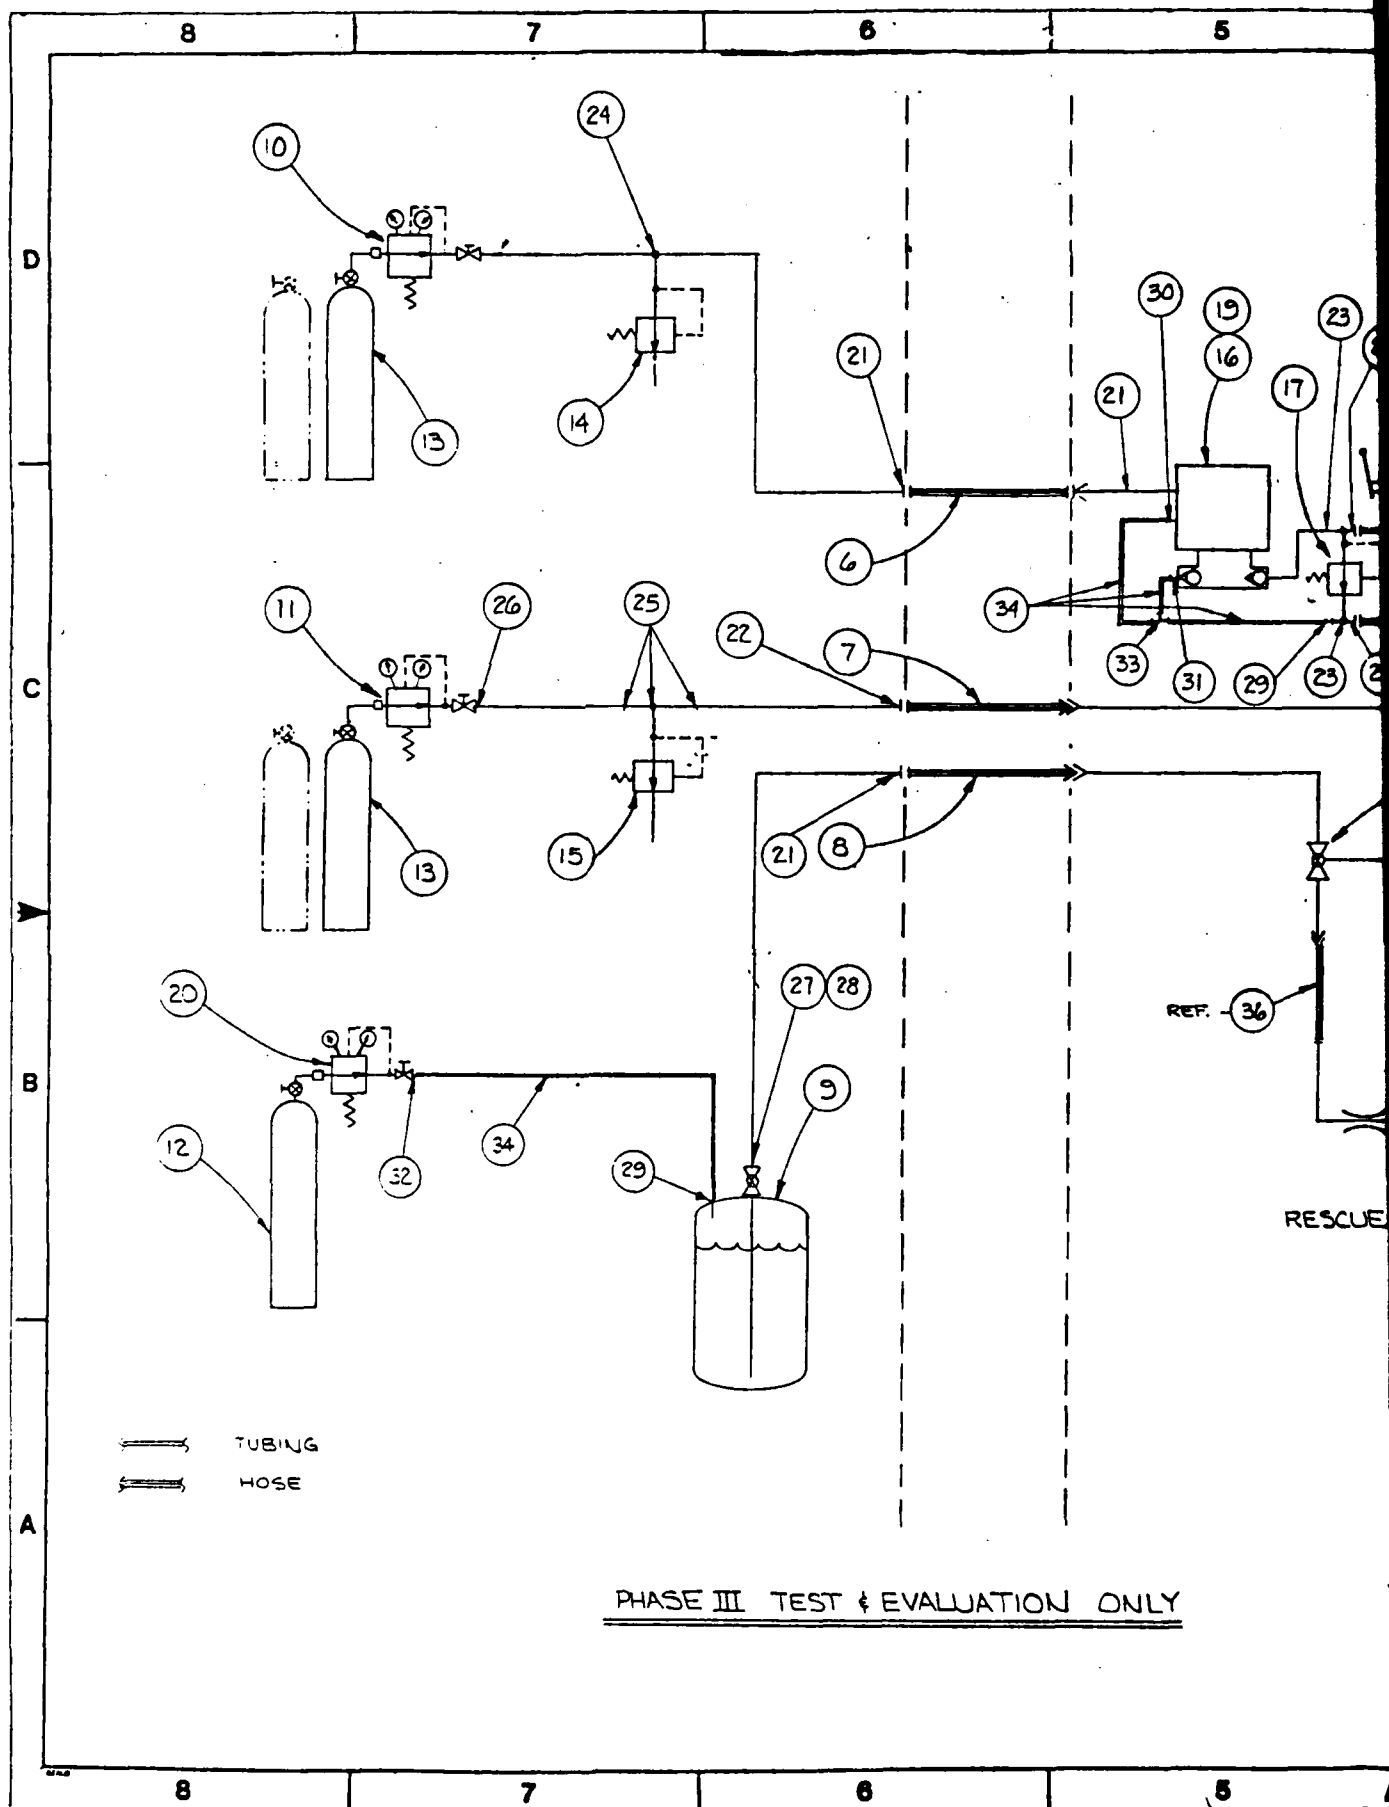
The rescue tool support equipment (Reference Figure 8-2) consists of three subassemblies and typically is located in the rescue truck.

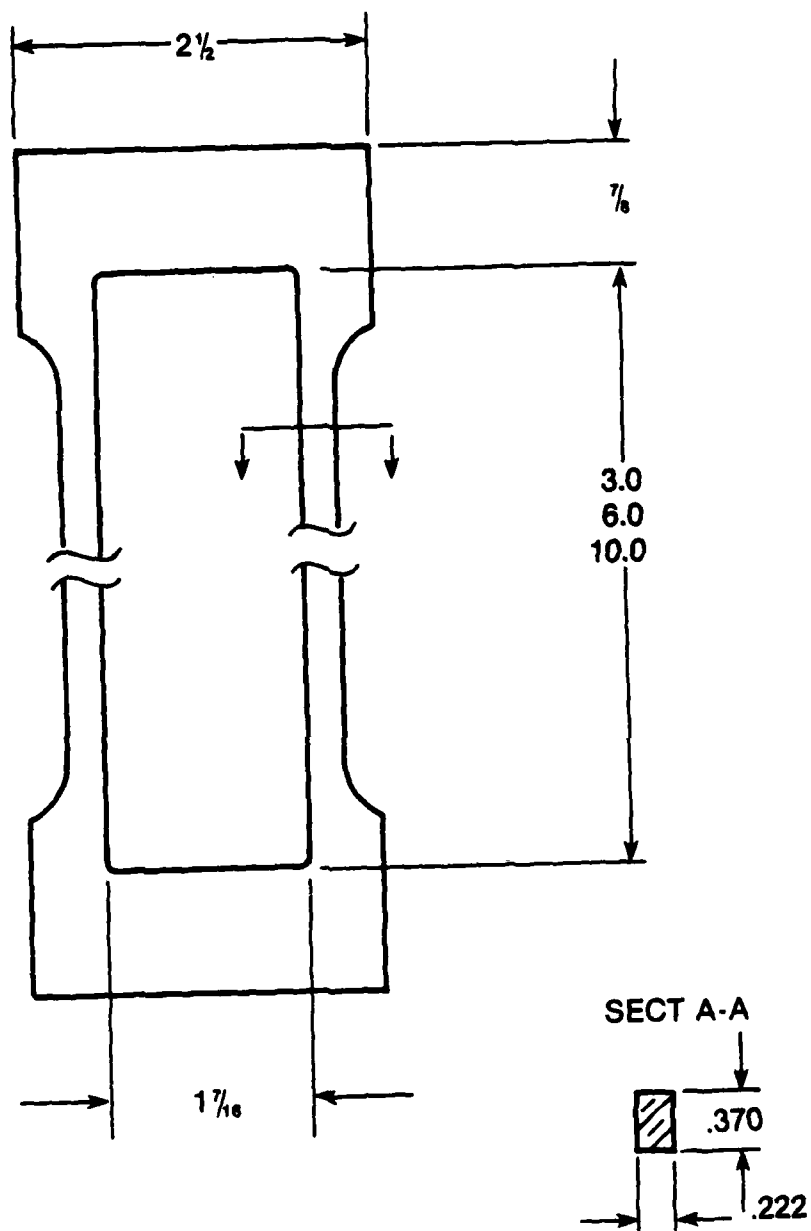
Figure D-1. Test Specimen

$$\text{Material thickness} = .370 \text{ in}$$

$$\text{Width} = .082 \text{ in}^2 / .370 \text{ in} = .222 \text{ in}$$

A breaking force of 7500 pounds was chosen due to the standard deviation of the material tensile strength and reasonable machining tolerances on the test specimen. The test specimen lengths were chosen to accommodate the range of jaw openings on the rescue tool. A quantity of test specimens (four 3-inch, four 6-inch, and three 10-inch) were fabricated and identified by reference designators A through K.
